# U.S. ARMY ENGINEER REACTORS GROUP

Report OSG 15

Final Report on Investigation of SM-1  
Control Rod Seal Failure

JOB 63 - INSPECTION  
OF SM-1 CONTROL ROD  
SEAL COMPONENTS

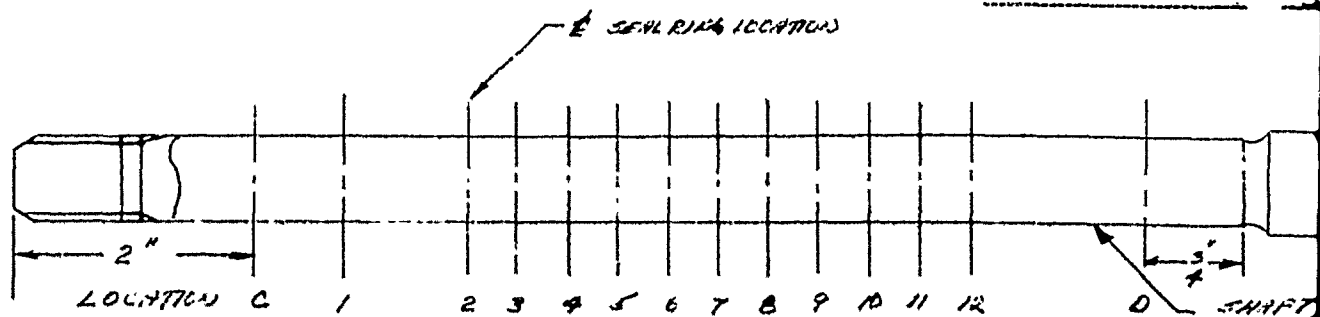
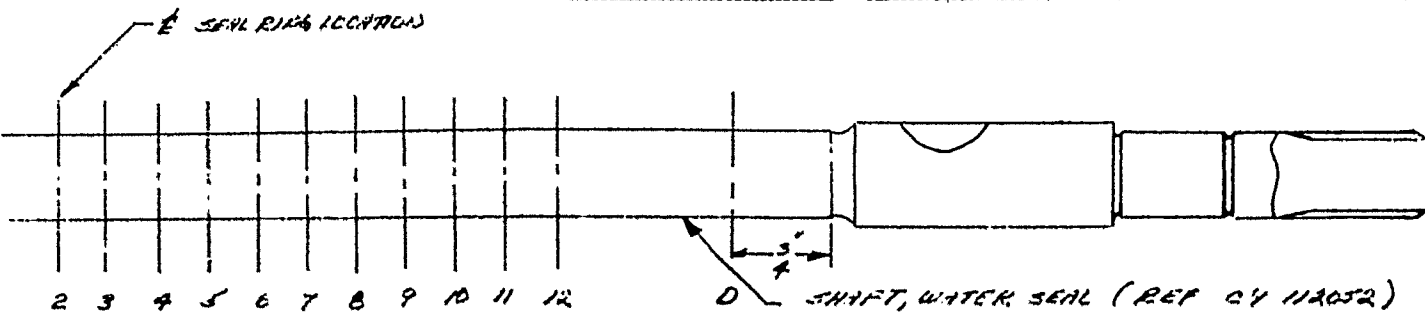
SKETCH #1

- \* SHAFT #1 HAD NO IDENTIFYING MARKS, SHAFT #2 WAS MARKED "2".
- ① DUE TO THE ALIGNMENT OF THE WEAR MARKS ON SHAFT #2 IT WAS CLEARLY EVIDENT THAT THE SEAL WAS INCORRECTLY ASSEMBLED. IT WAS ASSEMBLED AS FOLLOWS:

- ② ALTHOUGH THE MEASUREMENTS INDICATE LITTLE OR NO WEAR, EXAMINATION OF THE SHAFTS UNDER A MICROSCOPE SHOWED THAT THE CHROME PLATING HAD BECOME PITTED AT MOST OF THE SEAL RING MATING SURFACES. AT MANY PLACES THE DEGREE OF PITTING WAS SUCH THAT THE BASE METAL WAS VISIBLE.

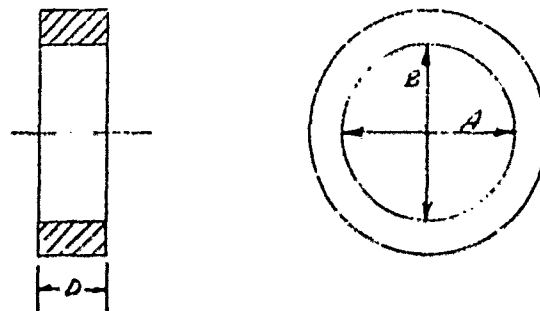
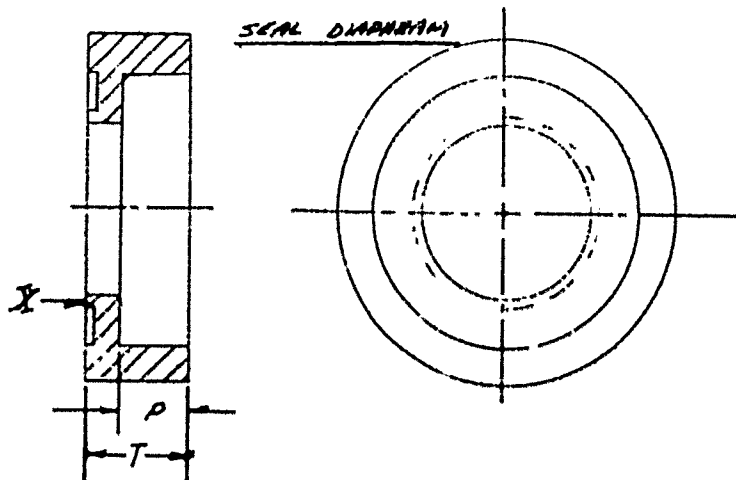
SKETCH # 2

① THERE WAS A CONSIDERABLE AMOUNT OF WEAR ON THE SIDE OF THE RINGS THAT MATES WITH THE SURFACE MARKED X IN THE ABOVE DIAPHRAM SKETCH. THE WEAR ON THE RINGS CONFORMED TO THE SHAPE OF SURFACE X. DUE TO THE ROUNDED ENDS ON THE MICROMETER ANVIL THE DEPTH OF THE WEAR WAS UNABLE TO BE DETERMINED. HOWEVER IT IS ESTIMATED THAT THE DEPTH WAS ONE TO TWO THOUSANDS OF AN INCH.

② ALL PARTS WERE ULTRASONICALLY CLEANED PRIOR TO ANY MEASUREMENTS AND NO SIGNIFICANT TRACE OF CRACK WAS EVIDENT

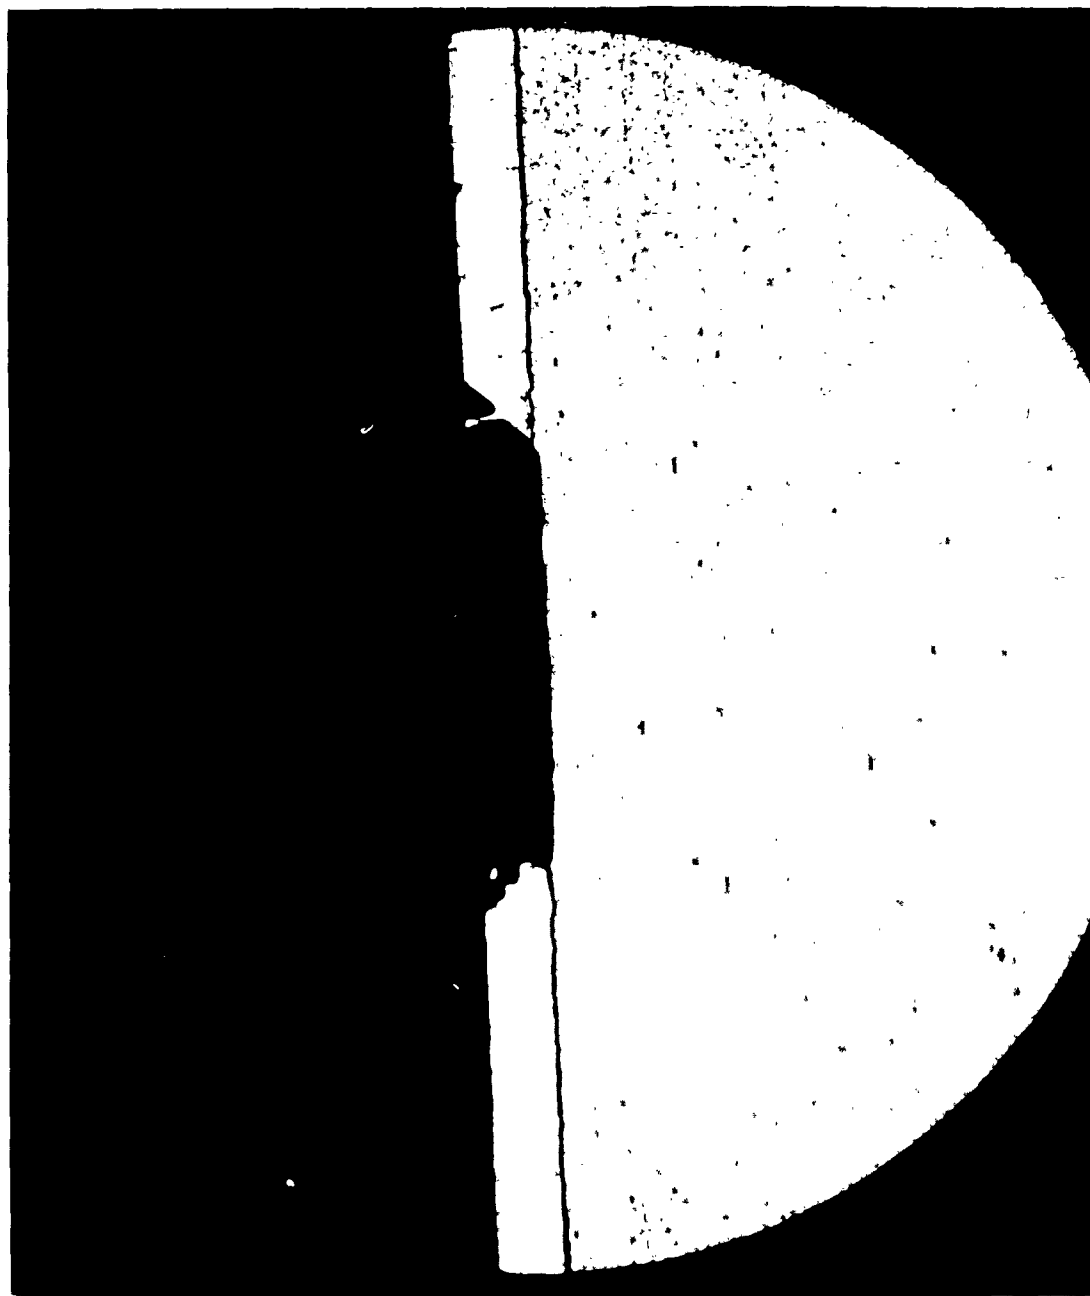
A longitudinal micro section through the center of this pit is shown in Figure 2 at 100 diameters.

Figure 2 - Longitudinal Section Through Large Pit Shown in  
Upper Right of Figure 1. (100X)

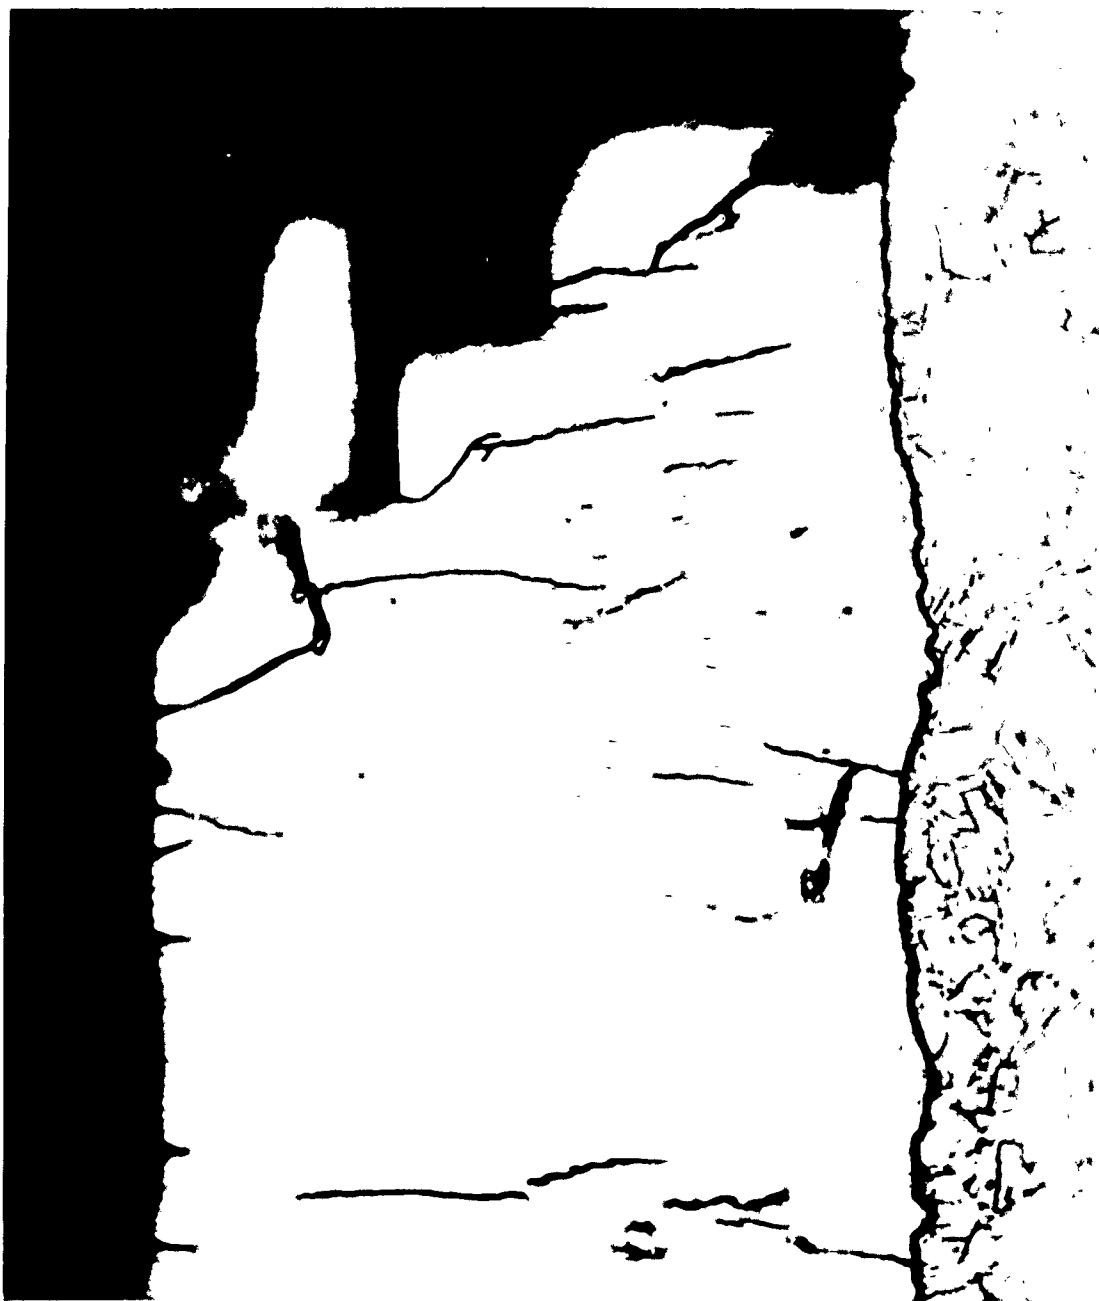
The left, or downstream edge of this pit is shown in Figure 3 at 1000 diameters. Careful examination of the exposed 17-4 PH surface material revealed no evidence of attack.

The non-metallic film or layer between the 17-4 PH base metal and the chromium deposit is clearly visible in Figures 3 and 4. This layer is approximately .00005" thick. Under polarized light, this layer seems to be the same material present in the chromium deposit in the form of vertical dikes and irregular inclusions.

Figure 3 - The Left or Downstream Side of Pit Shown in Figure 2  
at 1000 Diameters. (1000X)

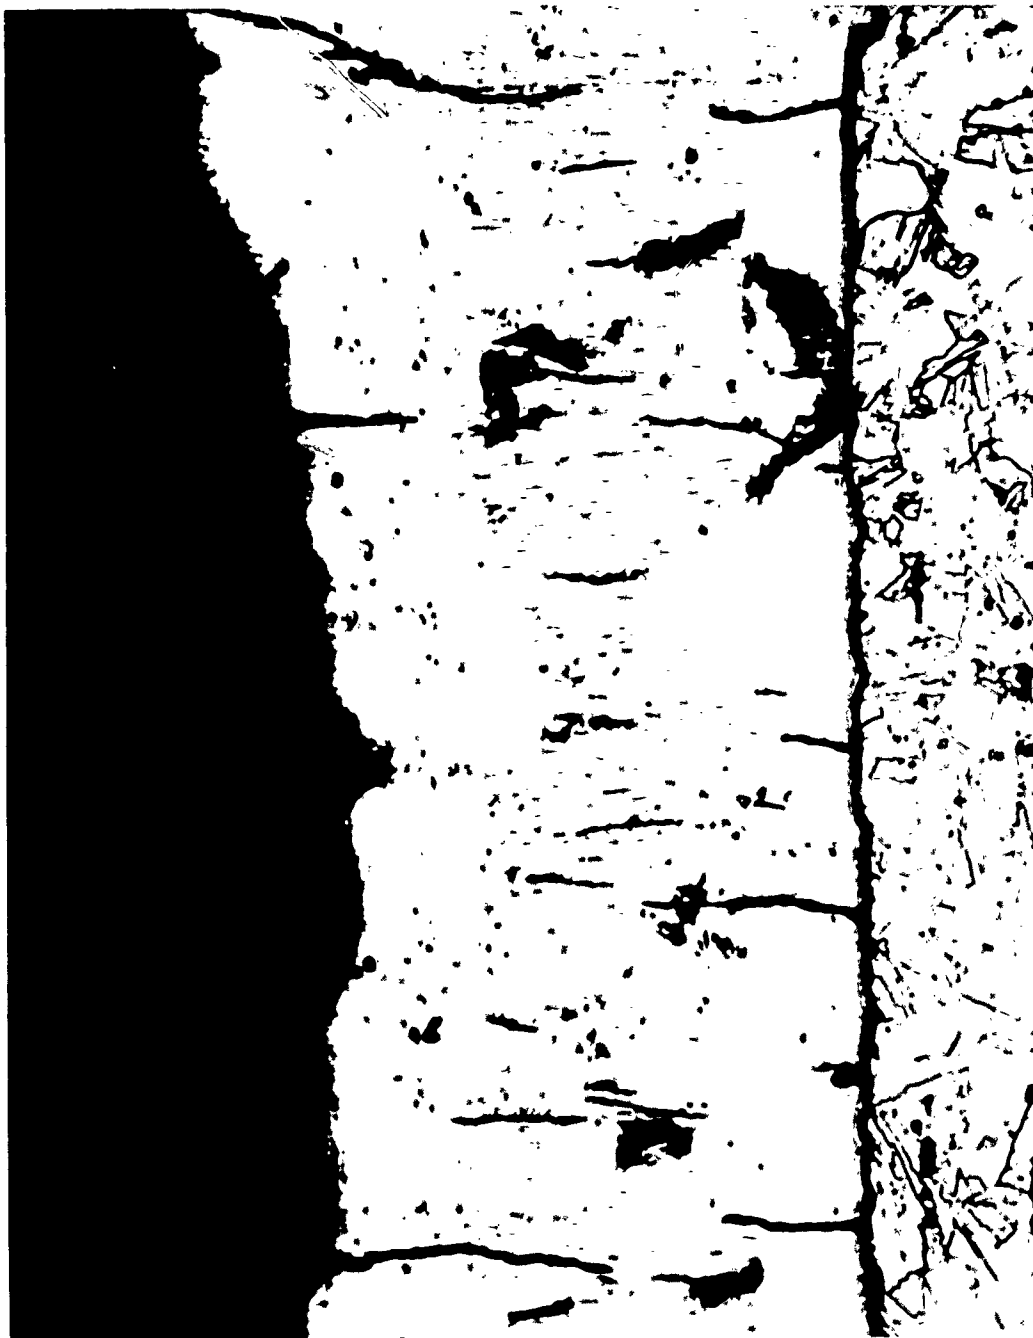
A longitudinal micro-section through a typically pitted or eroded area under a seal ring is shown in Figure 4 at 1000 diameters magnification. The chromium thickness at the lowest point is .0033". The thickness in unaffected areas is .005".

The presence of large non-metallic particles in the chromium plate is also shown in Figure 4. Similar particles at the surface could easily have been dislodged to form a site for accelerated pitting-type corrosion which ultimately led to the pit noted in Figure 1. This same type of chromium plate failure has been reported in a failure analysis study made by The Electrolyzing Company \* of over 650 chromium plated components.

The presence of numerous small sized particles as shown in Figure 4 could have contributed significantly to the corrosion and/or erosion exhibited in areas under seal rings. As reported by The Electrolyzing Company,\* grinding after chromium plating significantly increased the incidence of such particles exposed at the surface of the chromium plate.

Figure 4 - A Longitudinal Section Through Area Under Seal Shaft at 1000 Diameters. (1000X). At This Point .0013 Inch of Chromium Had Been Removed.

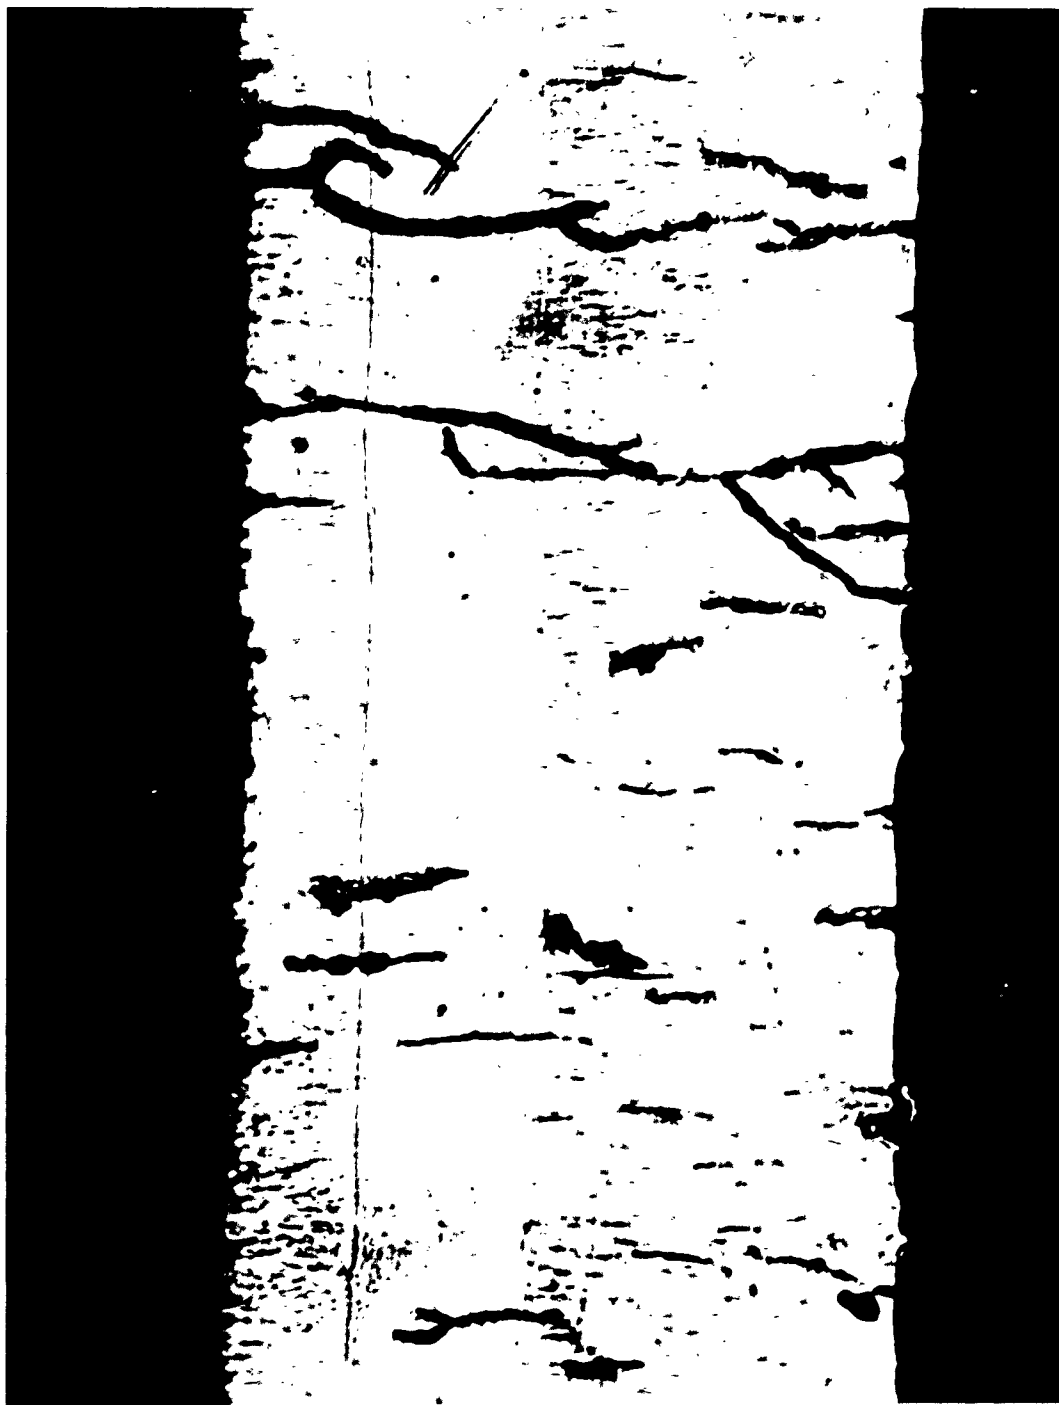
The deposit itself is definitely sedimentary. Three distinctly different layers are identified under polarized light, and may be seen on the bright field, Figure 5 at 950 diameters magnification, showing a relatively un-worn area.

Figure 5 - A Longitudinal Section Through a Relatively Unworn  
Area of Chromium Plate. (950X)

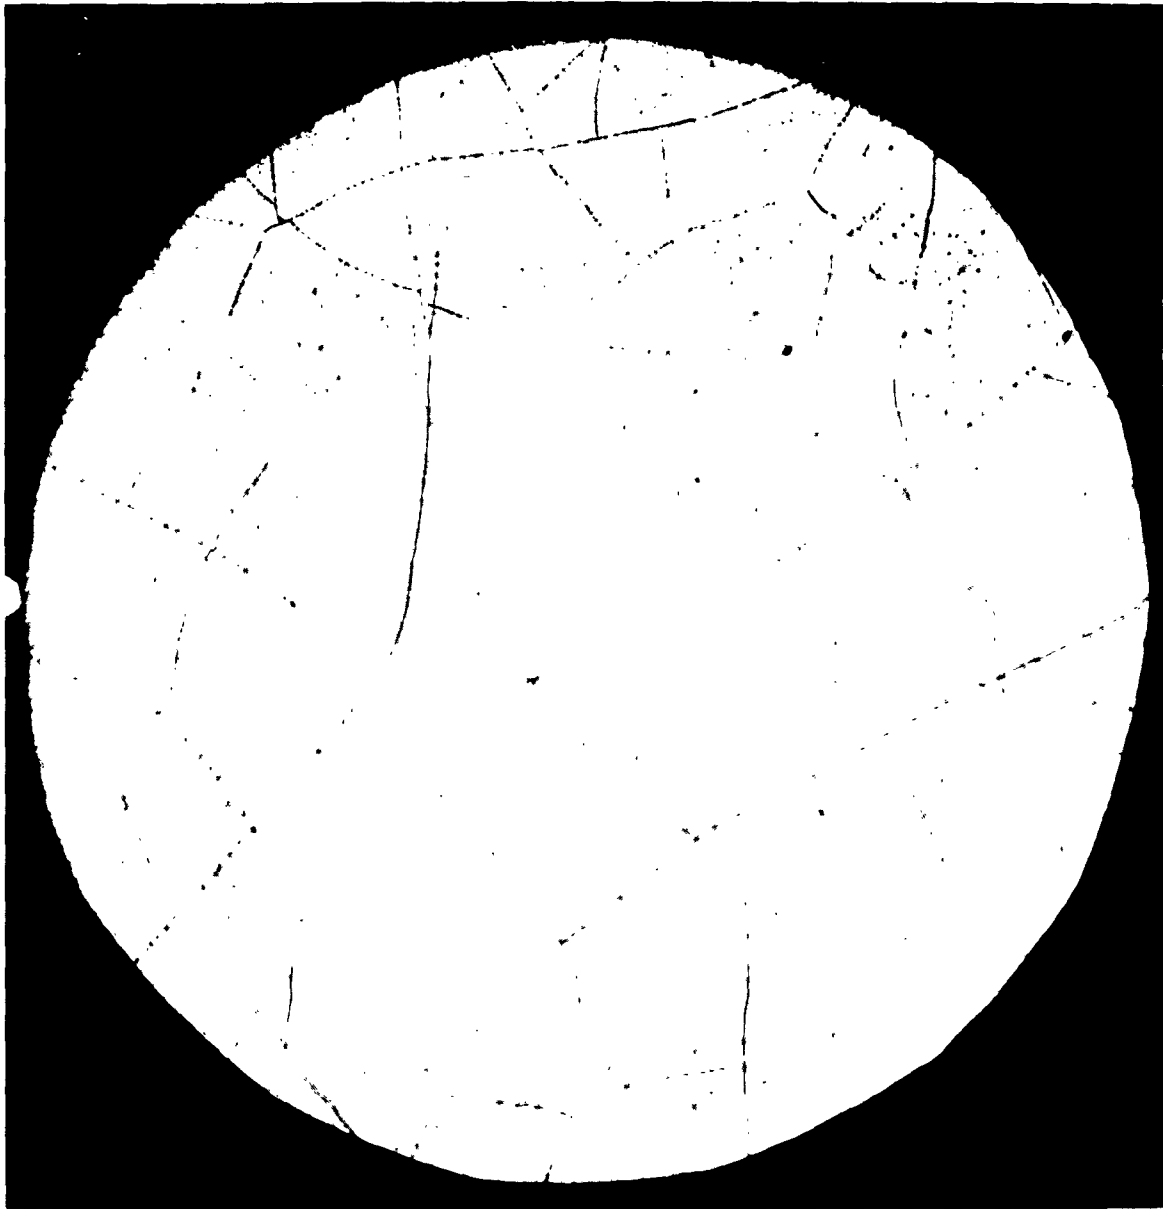
The chromium seal surface inherent crack pattern is shown at 250 diameters magnification in Figure 6. This pattern, showing 330 cracks per inch by lineal analysis, is indicative of chromium plate having high residual as-plated tensile stresses and low fatigue strength.\* Micro hardness readings of the plate averaged 900 Knoop with a 100 gram load, which is equivalent to Rockwell C-62.

**Figure 6 - Surface of SM-1 Seal Shaft Chromium Plate Showing Inherent Crack Pattern at 250 Diameters. This Crack Pattern Indicates by Linear Analysis a Pattern of 330 Cracks per Inch. (250X)**

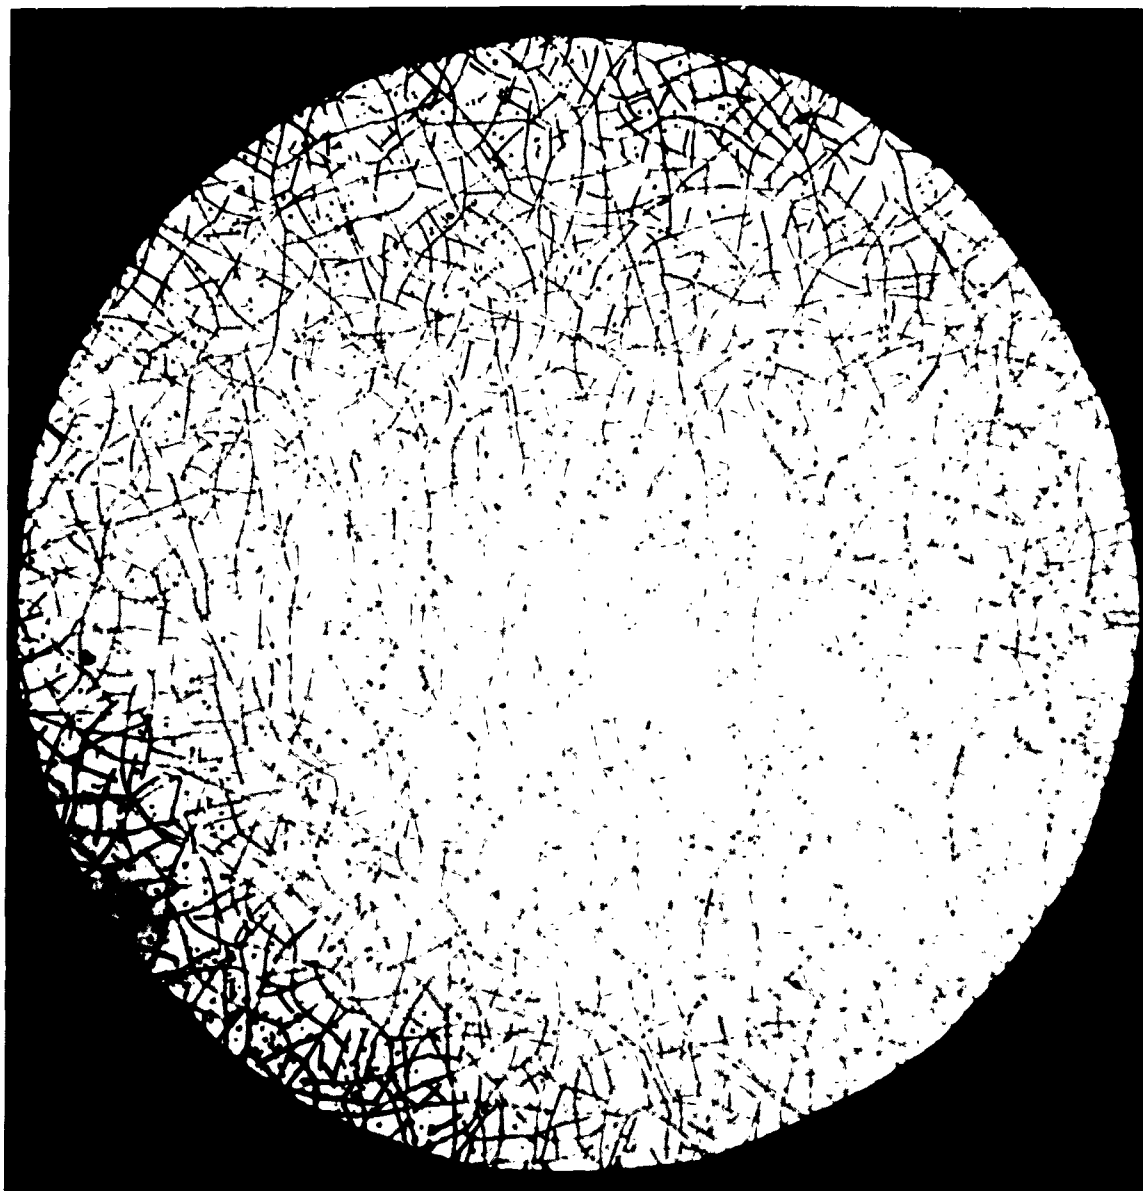
A satisfactory chromium plate is shown in Figure 7 at 250 diameters magnification. The crack pattern is 2750 cracks per inch, with a 100 gram Knoop hardness average of 1075 or equivalent Rockwell C-66. Total absence of the non-metallic intermediate layer is shown on Fig. 8, a longitudinal micro section photographed at 1000 diameters. This plating was performed under closely controlled conditions on a replacement seal shaft manufactured by Alco for The Elk River Reactor.

**Figure 7 - Surface of Satisfactory Chromium Plate Showing an  
Inherent Crack Pattern of 2750 Cracks per Inch. (250X)**
